Washington State School Seismic Safety Assessments Project

SEISMIC ASSESSMENT REPORT

VOLUME 1 OF 5

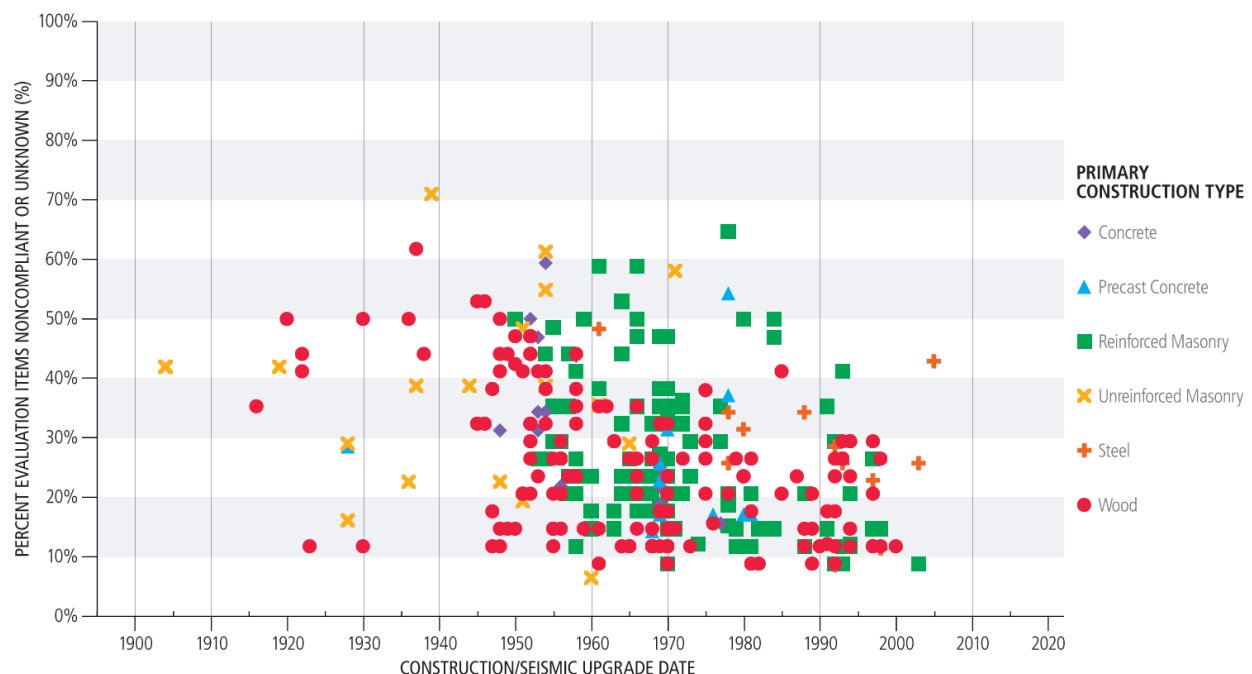
Figure 4.2.7-2. Percent ASCE 41 Tier 1 Items Identified as Noncompliant or Unknown Classified by Building Construction Type.
(Appendix Figure B.1-2)

The previous figure only shows the percent of items identified as noncompliant. It does not show items that are classified as unknown. Figure 4.2.7-2 shows the percent of items classified as either noncompliant or unknown. The horizontal axis is plotted by construction or seismic upgrade date. The vertical axis displays the percent of noncompliant or unknown items. The percent of noncompliant or unknown items for each building was determined by dividing the

Older buildings within each construction type tend to have higher percentages of seismically noncompliant or unknown items. Although, there is significant variability in the percentages of noncompliant and unknown items. There are many buildings built in the 1970s and 1980s that have higher percentages of noncompliant and unknown items compared to certain buildings built in the 1950s and 1960s. One URM building possesses a noncompliant or unknown percentage of about 70 percent. There is no discernable trend with URM buildings where buildings do not appear to be better or worse depending on age. There is no building that has zero noncompliant or unknown evaluation items.

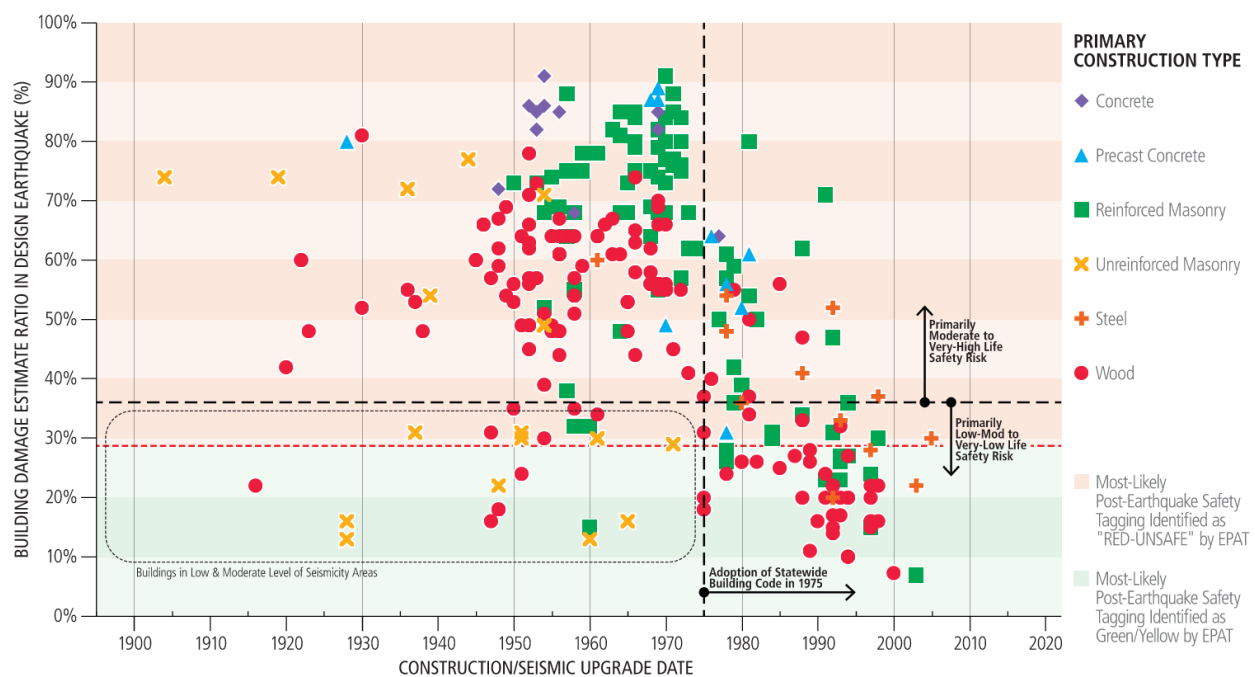
Figure 4.3-1. EPAT Damage Estimate Ratio Classified by Building Construction Type.
(Appendix Figure B.1-11)

Figure 4.3-1 shows the building damage estimate ratio in the design earthquake plotted against building construction or seismic upgrade date. The figure also includes different symbols for the building lateral system's primary construction material type.

The figure shows that school buildings built after 1975 have precipitously decreasing damage estimate ratios, with school buildings constructed in the 1990s and the 2000s generally possessing the lowest damage estimate ratios of all the school buildings evaluated. One significant factor in earthquake performance is the building code standard to which a building was originally designed. The EPAT spreadsheet separates Washington State into zones where the design standards at the time of construction were different. According to the EPAT documentation, historically the Puget Sound Region has had the strictest building code requirements. Buildings in the Puget Sound Region were also designed for the highest level of earthquake shaking due to the high seismicity of the region. Buildings in the rest of Washington State were historically designed to lower seismic force and detailing standards.

Starting in 1975, the state of Washington adopted a statewide building code for the first time. The adoption of a statewide standard made construction requirements uniform across the state. This adoption of the statewide standard, in addition to significant improvements in the building codes through the 1970s, 1980s, and 1990s, led to school buildings that are significantly more resilient to earthquakes compared to older school buildings. This is illustrated in the figure, with the decreasing damage estimate ratios for buildings built in the 1980s, 1990s, and 2000s.

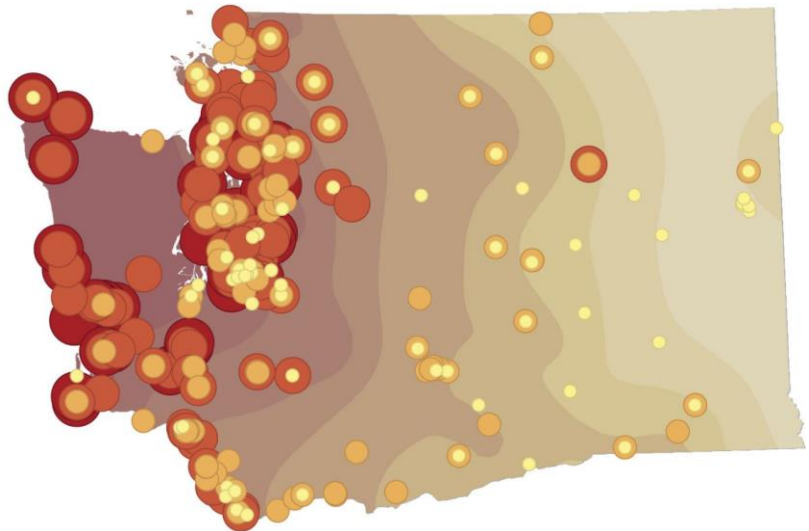
Figure 4.3-2. EPAT Damage Estimate Ratio Mapped Across the State (WA DNR, 2021).

Figure 4.3-2 shows a map of each school building and its EPAT building damage estimate ratio. Buildings located in western Washington tend to have higher damage estimate ratios than buildings in central and eastern Washington. However, building construction type and the quality of construction makes a significant difference, and there are some buildings in central and eastern Washington that are expected to experience higher amounts of damage.

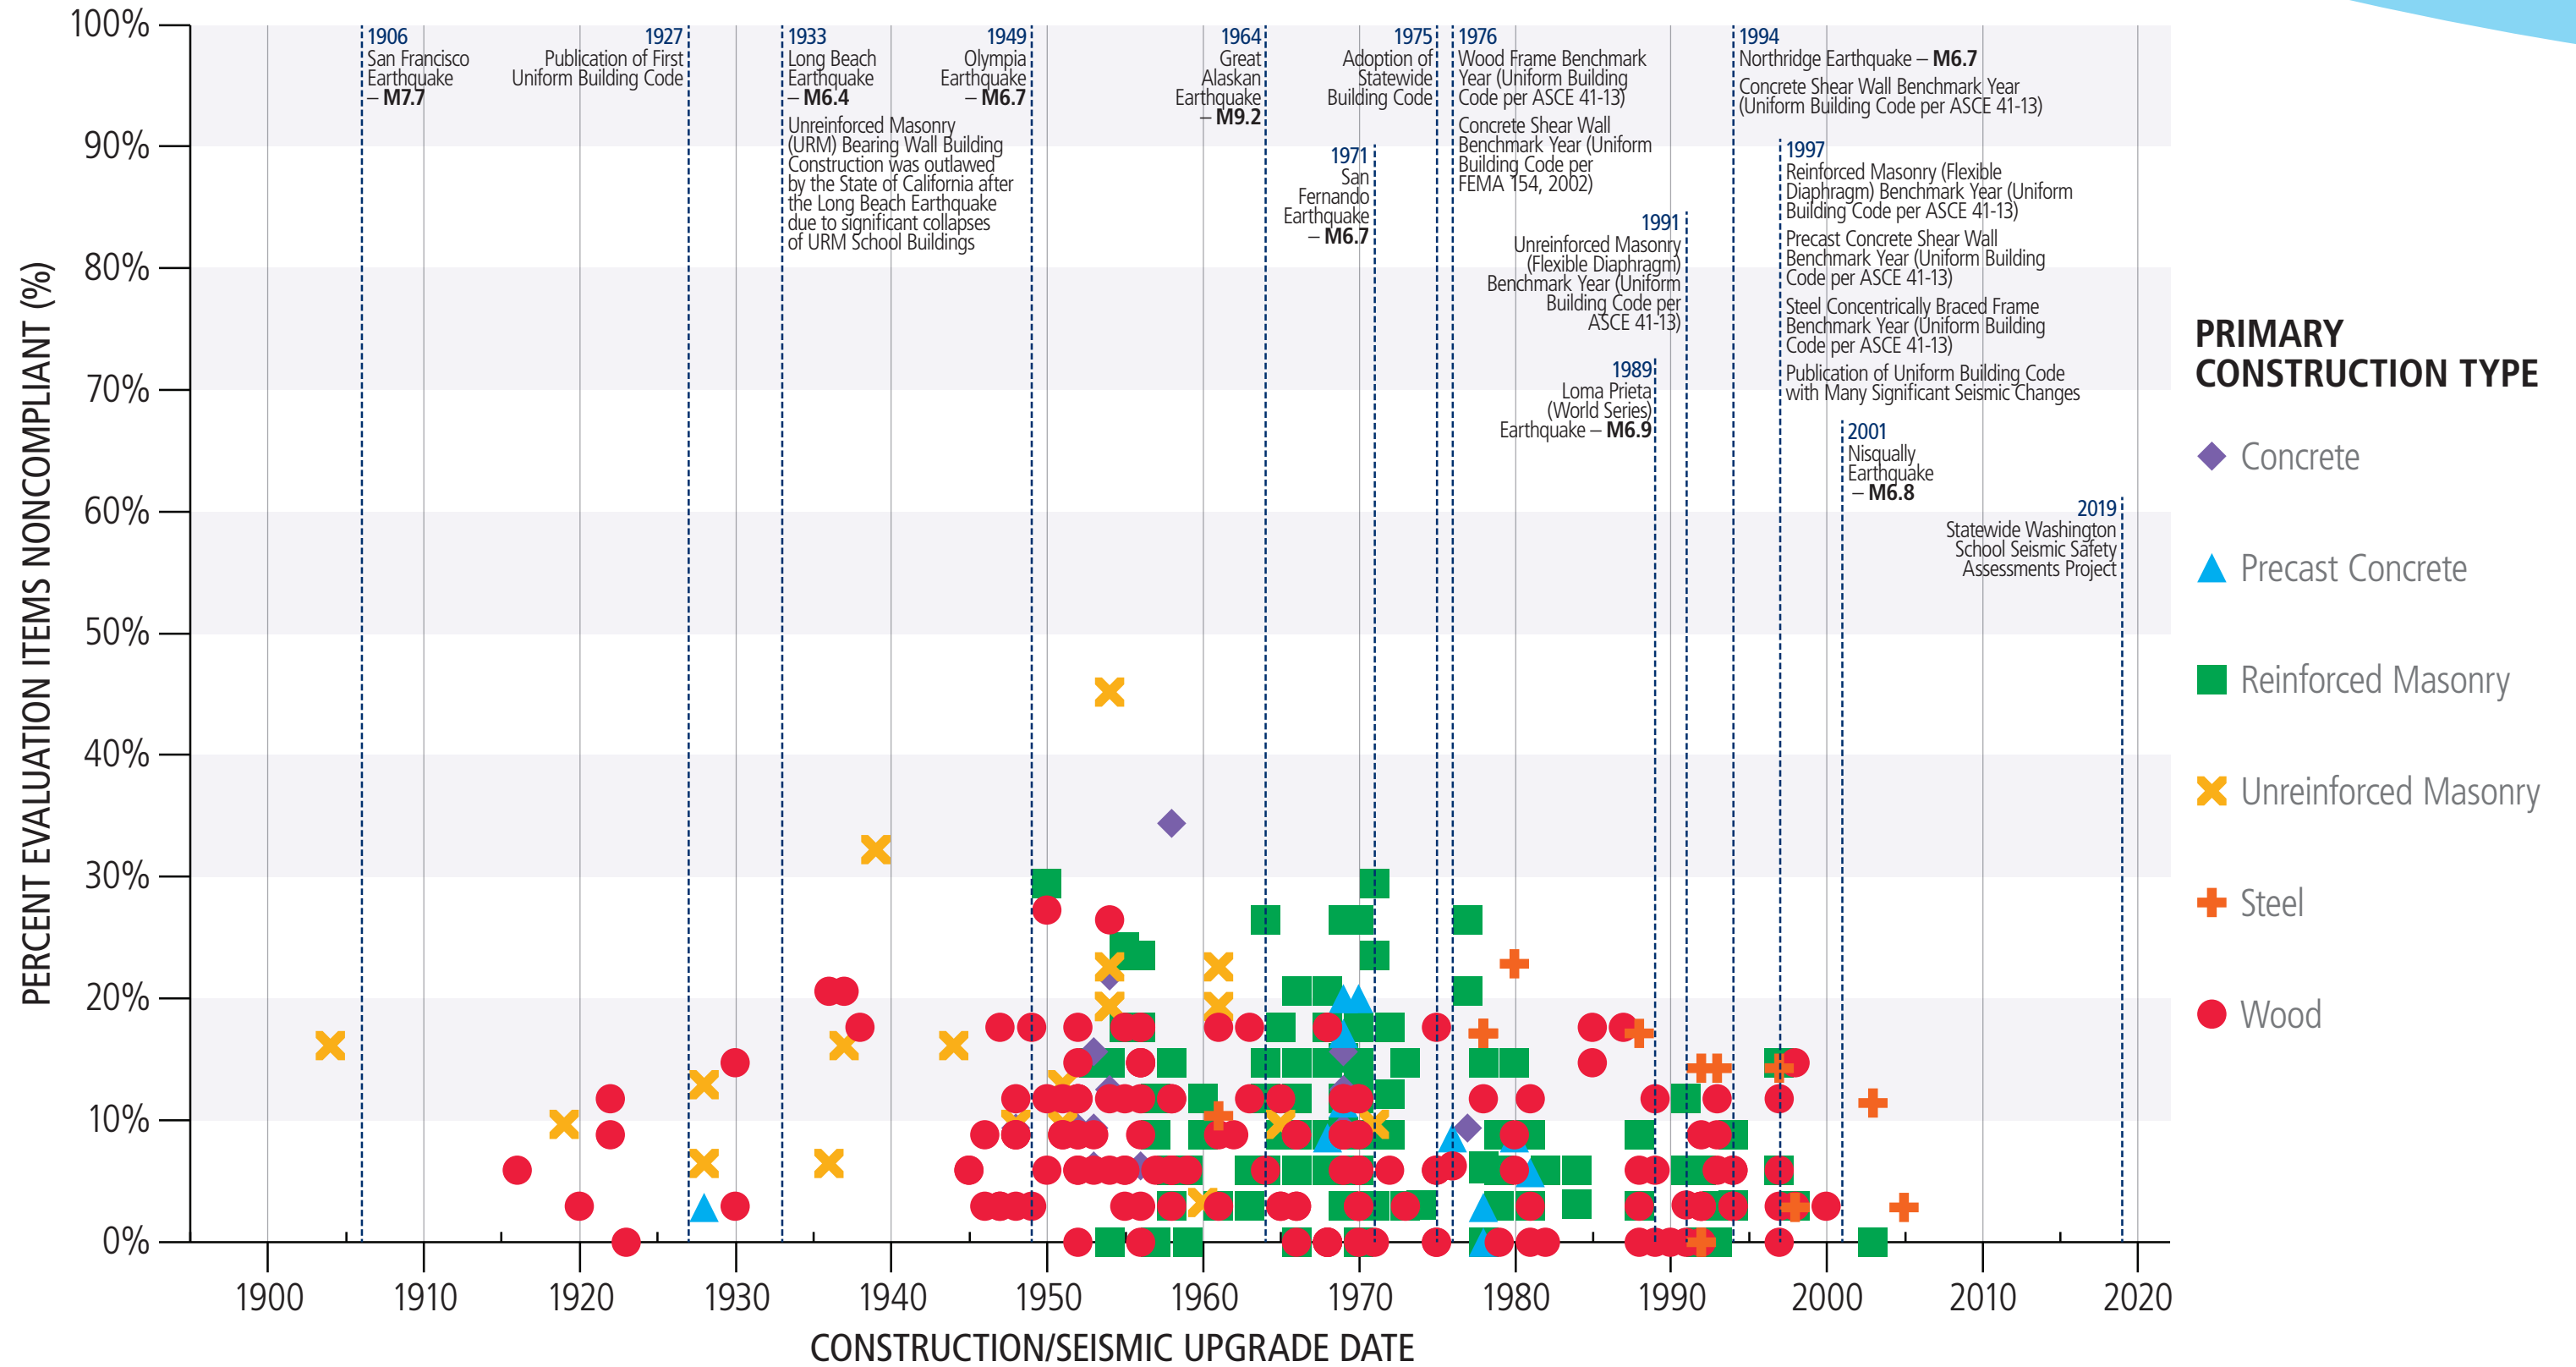
Figure B.1-1 – Phase 2 – ASCE 41 Tier 1 Percent Evaluation Items Noncompliant Categorized by Primary Construction Type

Figure 4.2.7-1 shows the percent noncompliant items that each building possesses, categorized by building type. The horizontal axis is plotted by construction or seismic upgrade date. The vertical axis displays the percent noncompliant items. The percent of noncompliant items for each building was determined by dividing the quantity of noncompliant items for each building by the total possible quantity of evaluation statements.
